**APPENDIX 1.6**

**DESCRIPTION OF AGC FACILITIES**  
**AT TIME OF PROPOSED CLOSURE, 2004**

## 1.0 DESCRIPTION OF THE SITES<sup>1</sup>

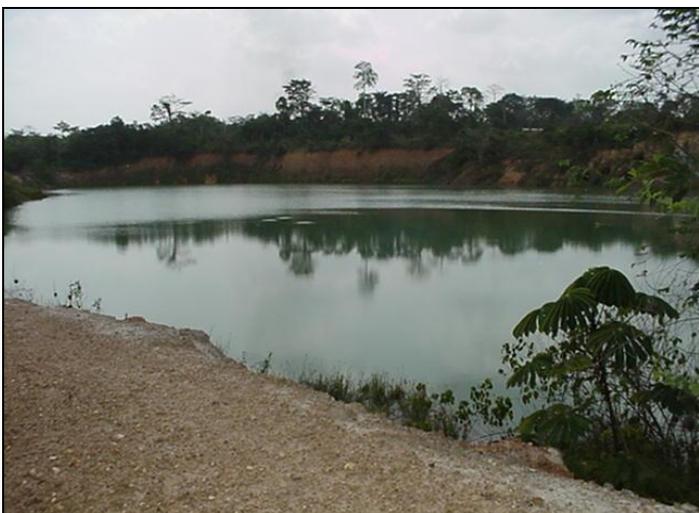
Photo 1.1

The pit is filled with water to a depth of 40m with 25m high of the NW pit walls above the water level, while the SE wall in contact with the access road has been reduced to about 7m above the water level.

The slope faces have developed small gullies as a result of erosion. Vegetation has developed around the pit perimeter in addition to the secondary forest at the background of the NW wall (Photo 1.1).

The walls of the pit are generally fairly stable with an average slope of 65°. However the northern wall has developed weak zones across the mid-portion of the face, which requires battering and re-contouring to stabilize it.

The pit is earmarked for development of aquaculture and forestry. The area is also designated for one of the sustainable livelihood support programmes.

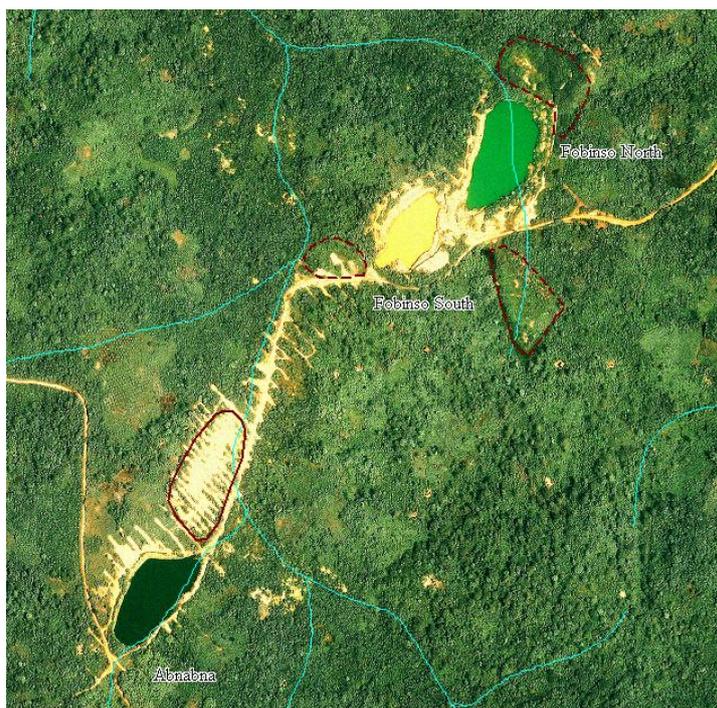
Photo 1.2

The pit has an oval shape elongated in the northeast–southwest direction (Photo 1.2). The major axis is about 400m and the minor axis is 200m with a depth of 40m, which is below the water table. The total coverage area is 8.2 hectares. The volume of material mined out has been estimated to be 689,652 m<sup>3</sup>.

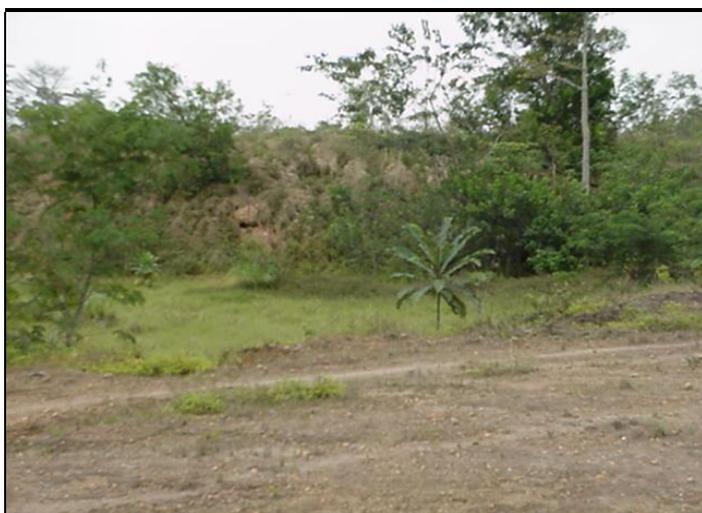
**Photo 1.3**

Waste material dumped was from the Abnabna pit and made up mainly of pieces, fragments and some boulders of phyllites and metasediments set in tuffaceous clayey groundmass. Material is all weathered, no sulphide minerals are present

Battered and planted to forest trees.

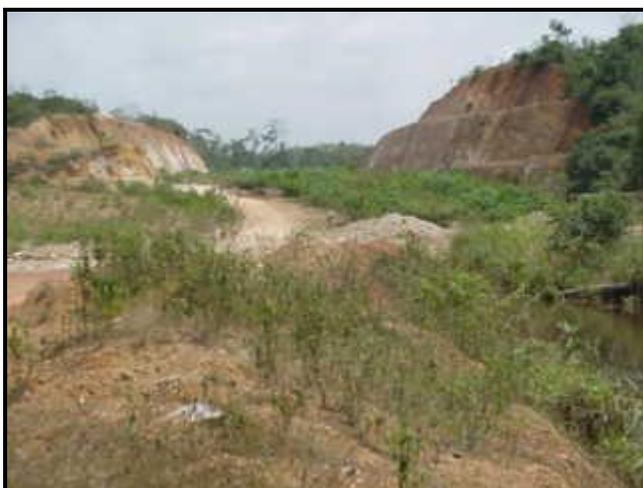
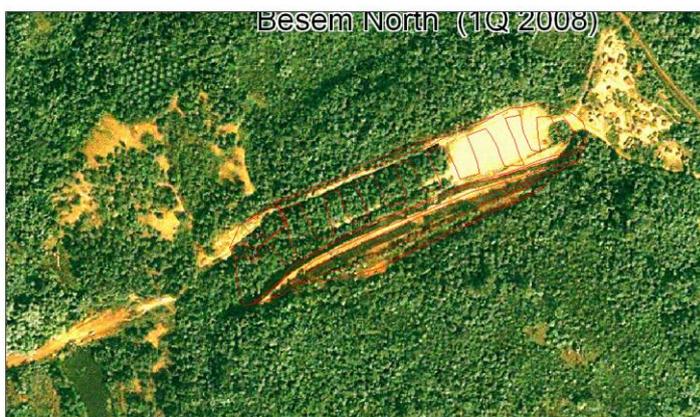
The pit has been reclaimed by backfilling above the daylight elevation, leaving 20m high pit walls to the east and the west flanks of 2 benches of 10m high. A portion of the reclaimed pit area has been turned into agro-forestry after the spread of topsoil and the provision of erosion control structures while the remaining land has been turned into a playing field (Plate 1a).

The west wall has a slope of 70° eastwards, is generally stable with small ditches formed parallel to slope face due to surface run-offs (erosion). The east wall has a slope of 75° westwards with weak zones developed across the mid-section of the face, requiring battering and re-contouring to stabilize it.

The proposed end use for the reclaimed pit is agroforestry. Already grass species, Cassia species, Ceiba pentandra, Mangifera species, etc. have been planted and are doing well.

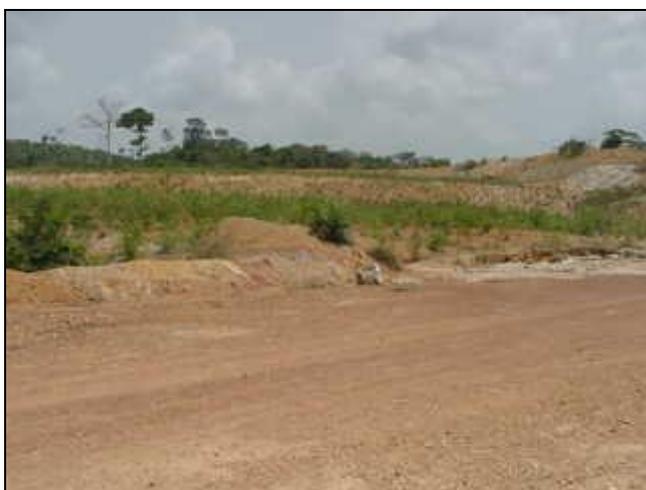
**Photo 1.6**

Part of the material dumped on top has been used to back-fill the Besem North Pit, creating substantial reduction in the dump height and volume. This has been followed with surface preparation by contouring, re-deposition of topsoil to sustain re-vegetation and provision of erosion control structures. The waste dump is now overgrown with nitrogen fixing plant species (Plate 1b).

The waste dump has been earmarked for forestation to serve as the northern protection to the Asanka stream

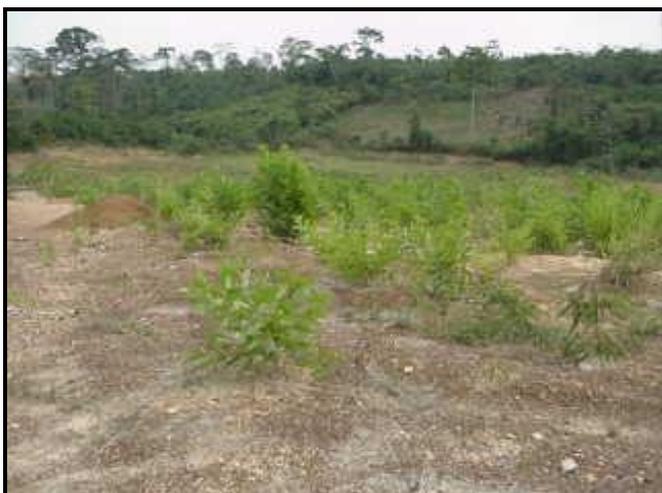
Photo 1.7

Backfilling has been completed. Topsoil spread and vegetative cover put in place with the encouragement of natural fauna growth. The absence of high pit walls coupled with improved drainage makes the reclaimed pit ideal for re-institution of original land use namely, oil palm plantation. The reclaimed pit area is currently been prepared for soil structure resuscitation (Plate 2a).

All pit walls have been successfully battered and stable slope angles achieved. The land is gentle rolling and soil movement checked through consistent erosion control measures.

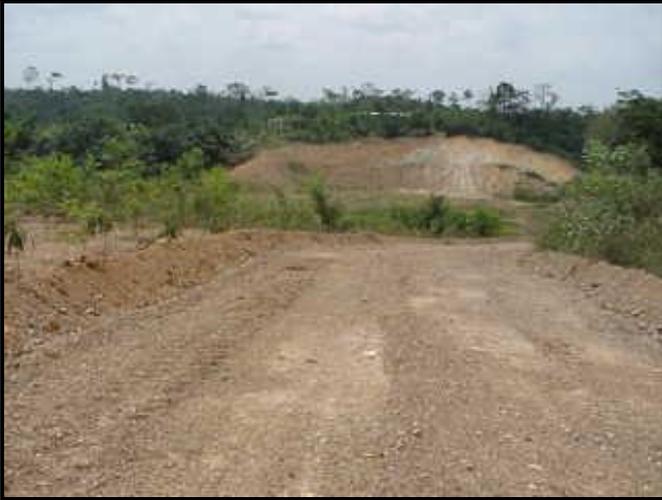
**Photo 1.8**

Extensive backfilling has been carried out with pit walls battered to gentle and stable slopes. Topsoil has been spread and vegetative cover put in place. Nitrogen fixing plant species have been introduced over a year ago and the growth performance is being monitored for improvement. Erosion control measures towards the northern slope have to be improved upon with reinforcement of undergrowth vegetation (Plate 2b).

All pit walls have been successfully battered and stable slope angles achieved. The land is gentle rolling and soil movement checked through consistent erosion control measures.

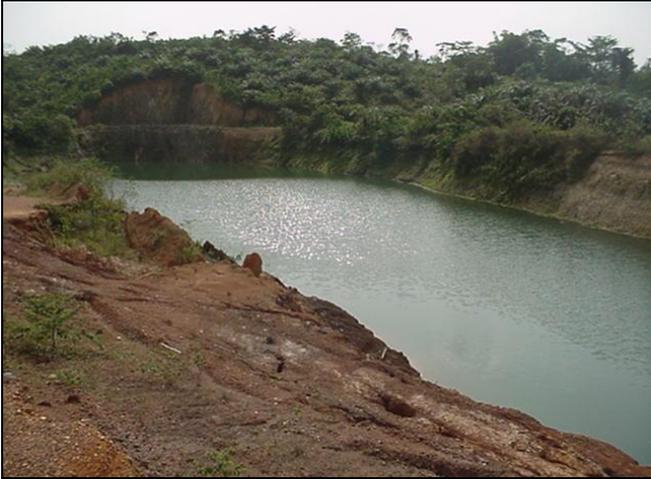
**Photo 1.9**

The walls of the pit are steep with an average slope of about 65° and are generally unstable. Weak zones and faults have developed in the east, west and north walls, with failures in the north and east walls. Erosion has caused gully developments in the slope faces. Manual remedial work would be undertaken to improve erosion and prevent any adverse instability problems.

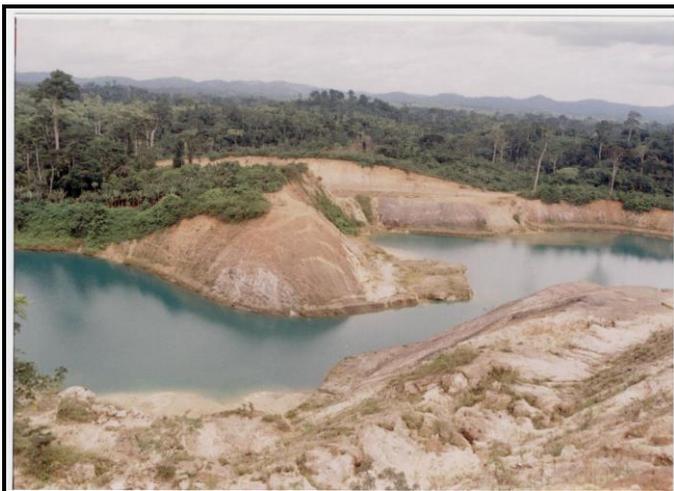
Photo 1.11

The walls of the main pit are steep with an average slope of about 70°. At the southwest wall there are 4 benches, 3 of which have regular 7m heights above the water with the first bench about 25m high. The northern wall has very high bench of about 24m. The NW wall is about 60m high of 3 benches of about 20m high with 3 levels of narrow interrupting berms. All the pit walls including those of the east pit are in stable condition. Manual remedial work would be undertaken to improve erosion and prevent any adverse instability problems.

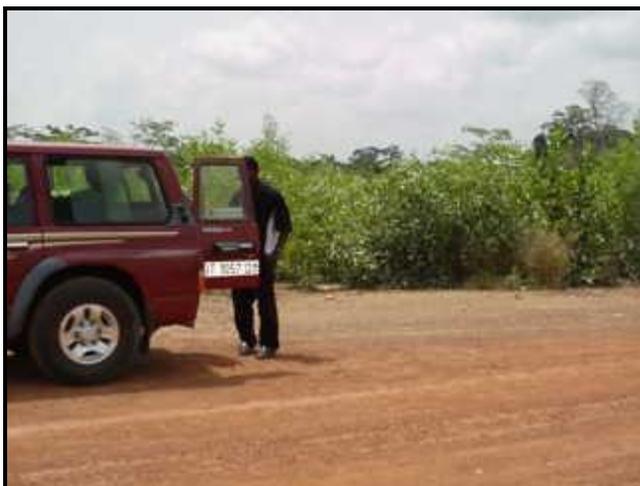
Photo 1.18

In backfilling North Esuajah pit, some of the material from this waste dump was recovered and used. The remaining heap of waste material was battered to obtain slope stability and topsoil spread on top for revegetation. Continuous erosion control activities have been designed to prevent soil damage and restore vegetation. Most of the species planted are nitrogen-fixing plants. To accelerate early vegetative undergrowth, both organic and inorganic fertilizers have been introduced. Deep ripping has reduced erosion considerably and there is a regular maintenance program in place to mitigate any negative topographic development (Plate 3b).

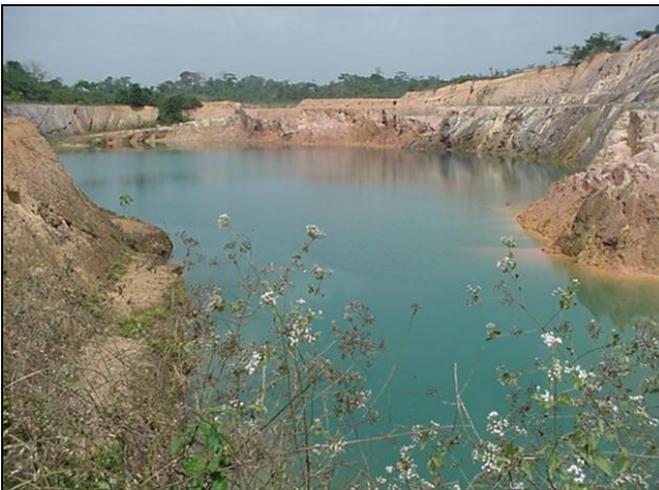
Photo 1.29 Fobinso South

The walls of the pits are steep with an average slope of 65°. While the slopes of the north pit are fairly stable, the south pit walls have developed weak zones and minor slope failures. The effect of erosion is evidenced by the presence of gullies all over the slope faces. Manual remedial work would be undertaken to improve erosion and prevent any adverse instability problems.

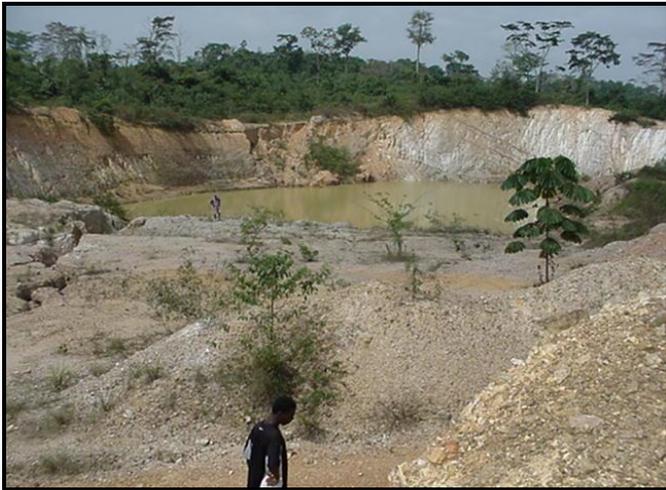
**Photo 1.35**

The pit is partially reclaimed by backfilling the southern end above daylight elevation, and the northern end filled with water to 10m deep leaving 30m of the wall above it. The area beyond the pit is covered with secondary forest and other vegetation (Plate10a). Illegal mining operation going on there is causing further land degradation in the area.

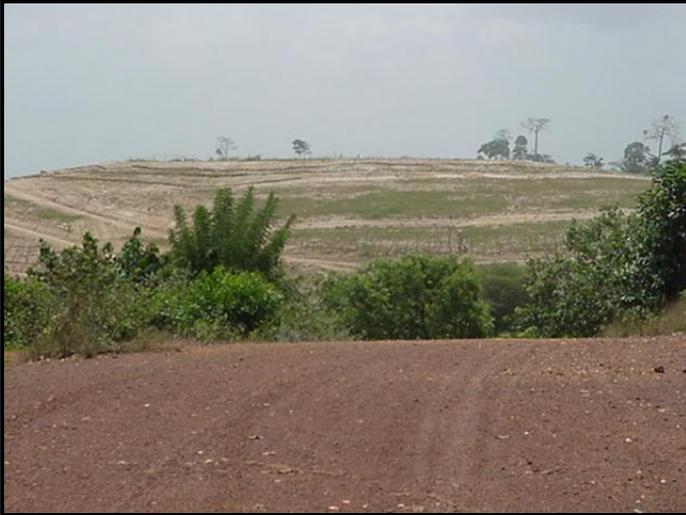
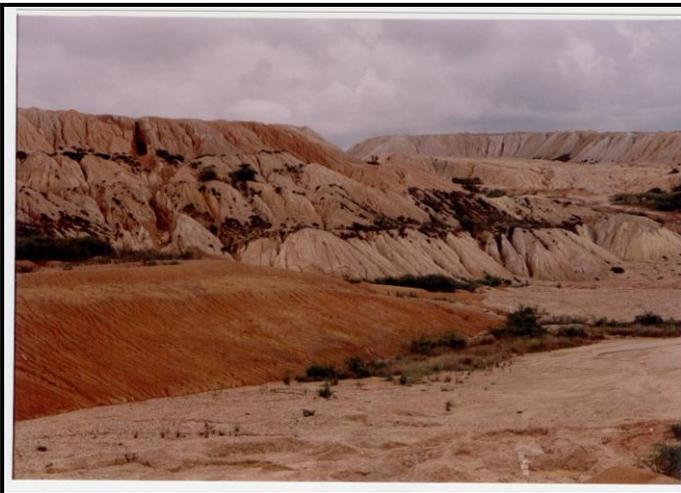
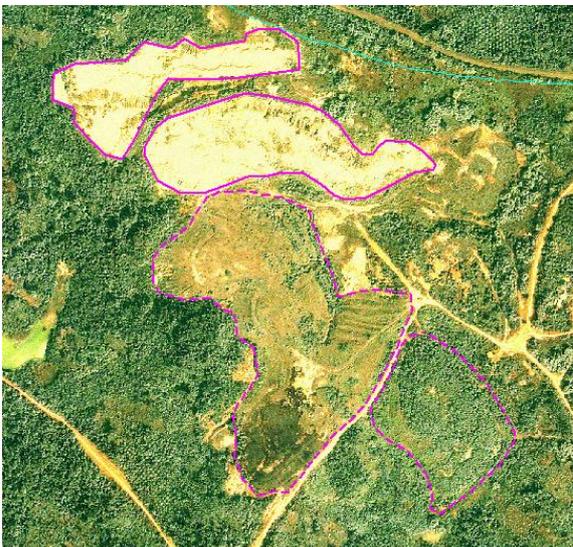
The 70° heap faces are generally unstable. Gully formation could undermine the berms provided and consequently accelerate slope failure. As part of the restoration, stability designs and works have tentatively been developed to address the negative impact.

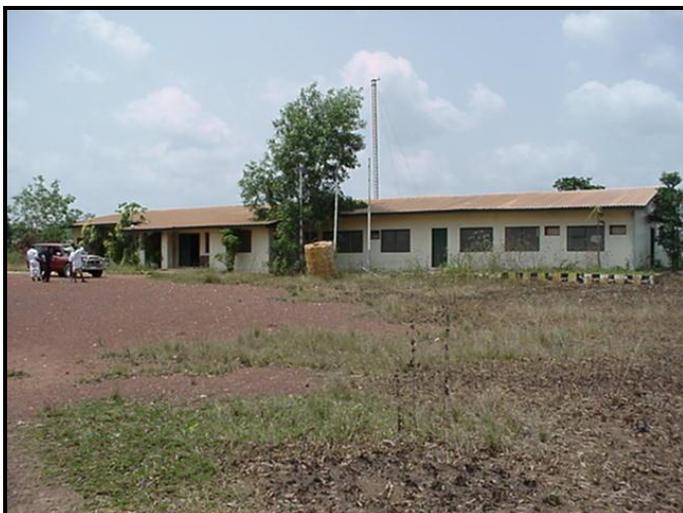
Photo 1.40

The facilities in this area are all in good structural conditions, but the inside of the clinic and the stores have been stripped of everything including the ceilings (Plate 15a).

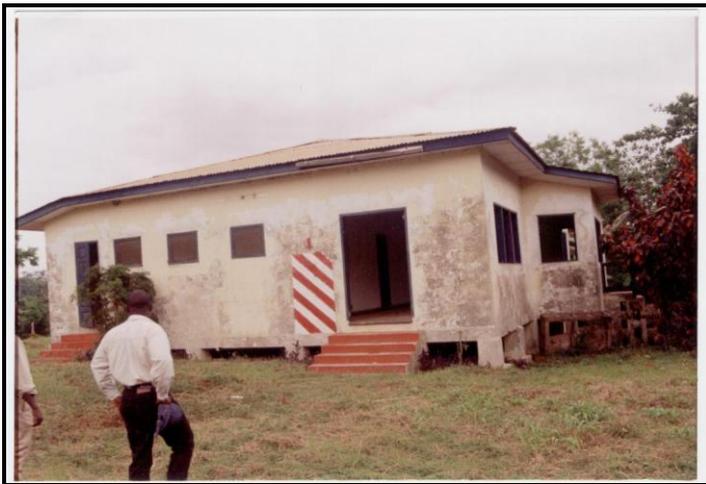
**Photo 1.41**

All the buildings are in good structural condition and can be used for any suitable activity (Plate 16a). However, most of the fittings and the utility facilities (louver blades and holders, plumbing accessories, electrical fittings, etc.) have either been destroyed or stolen.

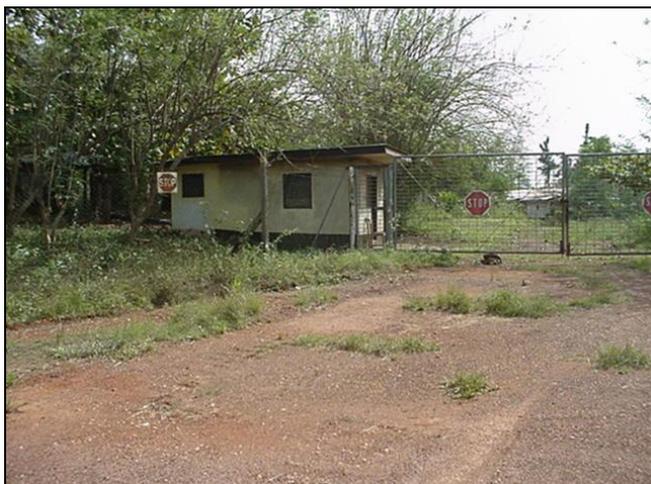
Photo 1.42

Service utilities are intact with camp maintenance being undertaken by the Estates Department of AGC (Plate 16b). The access road is constantly kept in good condition through the ongoing environmental management process.
