APPENDIX 1.6

**DESCRIPTION OF AGC FACILITIES
AT TIME OF PROPOSED CLOSURE, 2004**

1.0 DESCRIPTION OF THE SITES¹

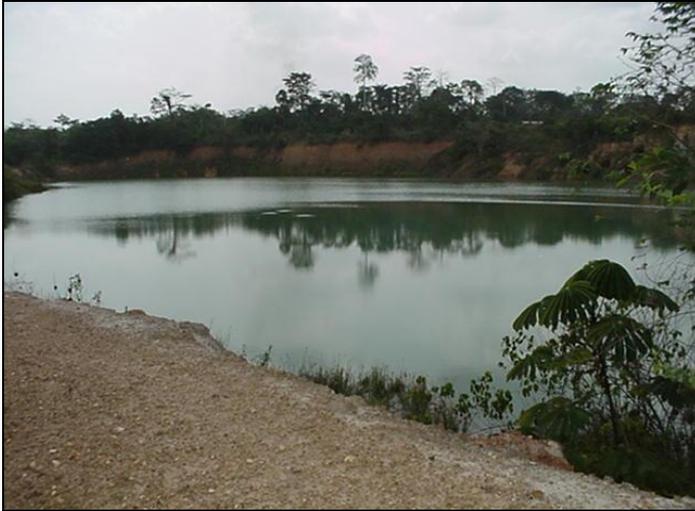
Photo 1.1

The Abnabna Pit (Photo 1.1) is located 2 km southeast of the Abnabna village (Map 1.1).

The pit is filled with water to a depth of 40m with 25m high of the NW pit walls above the water level, while the SE wall in contact with the access road has been reduced to about 7m above the water level.

The slope faces have developed small gullies as a result of erosion. Vegetation has developed around the pit perimeter in addition to the secondary forest at the background of the NW wall (Photo 1.1).

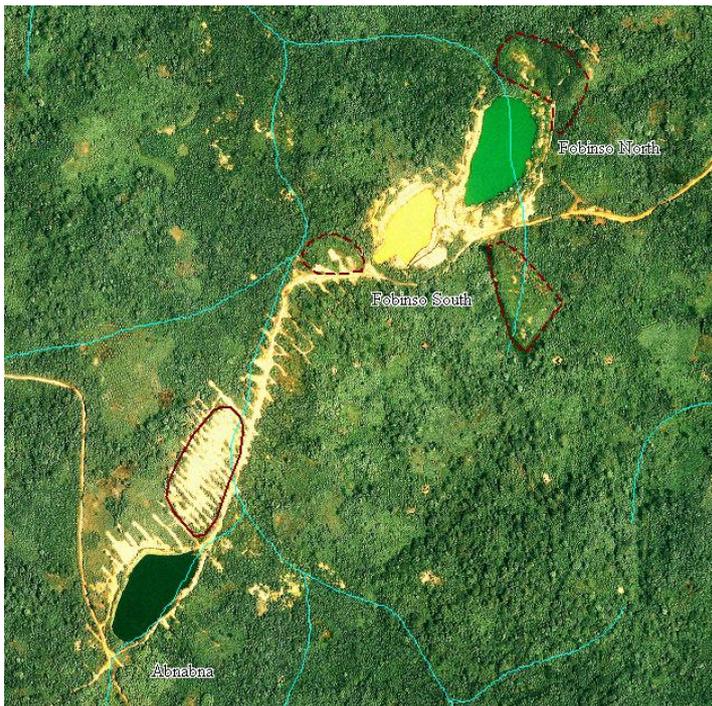
Photo 1.2

The pit has an oval shape elongated in the northeast–southwest direction (Photo 1.2). The major axis is about 400m and the minor axis is 200m with a depth of 40m, which is below the water table. The total coverage area is 8.2 hectares. The volume of material mined out has been estimated to be 689,652 m³.

The walls of the pit are generally fairly stable with an average slope of 65°. However the northern wall has developed weak zones across the mid-portion of the face, which requires battering and re-contouring to stabilize it.

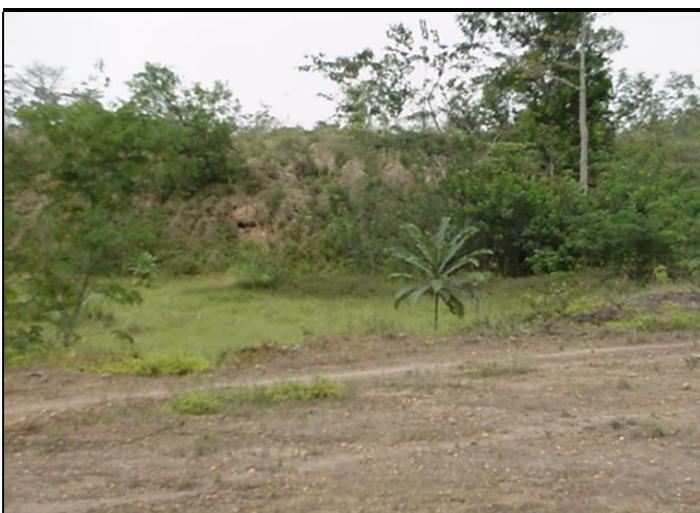
Photo 1.3

Waste material dumped was from the Abnabna pit and made up mainly of pieces, fragments and some boulders of phyllites and metasediments set in tuffaceous clayey groundmass. Material is all weathered, no sulphide minerals are present

Battered and planted to forest trees.

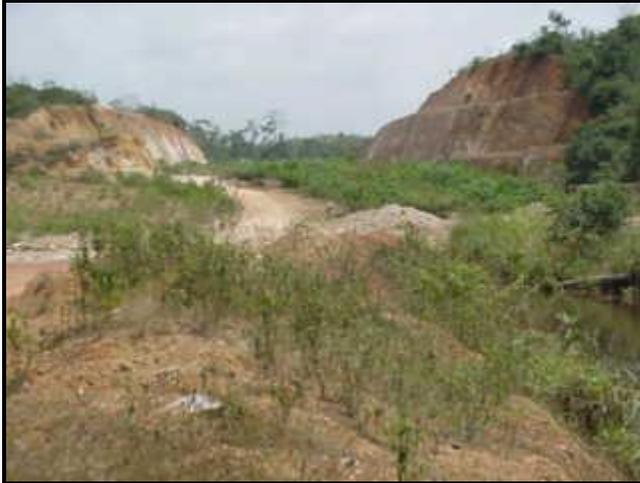
Photo 1.4

The pit has been reclaimed by backfilling above the daylight elevation, leaving 20m high pit walls to the east and the west flanks of 2 benches of 10m high. A portion of the reclaimed pit area has been turned into agro-forestry after the spread of topsoil and the provision of erosion control structures while the remaining land has been turned into a playing field (Plate 1a).

The west wall has a slope of 70° eastwards, is generally stable with small ditches formed parallel to slope face due to surface run-offs (erosion). The east wall has a slope of 75° westwards with weak zones developed across the mid-section of the face, requiring battering and re-contouring to stabilize it.

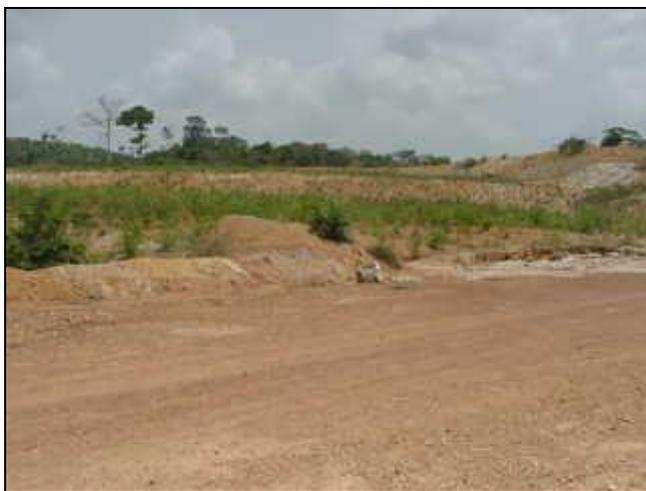
Photo 1.6

Part of the material dumped on top has been used to back-fill the Besem North Pit, creating substantial reduction in the dump height and volume. This has been followed with surface preparation by contouring, re-deposition of topsoil to sustain re-vegetation and provision of erosion control structures. The waste dump is now overgrown with nitrogen fixing plant species (Plate 1b).

The waste dump has been earmarked for forestation to serve as the northern protection to the Asanka stream

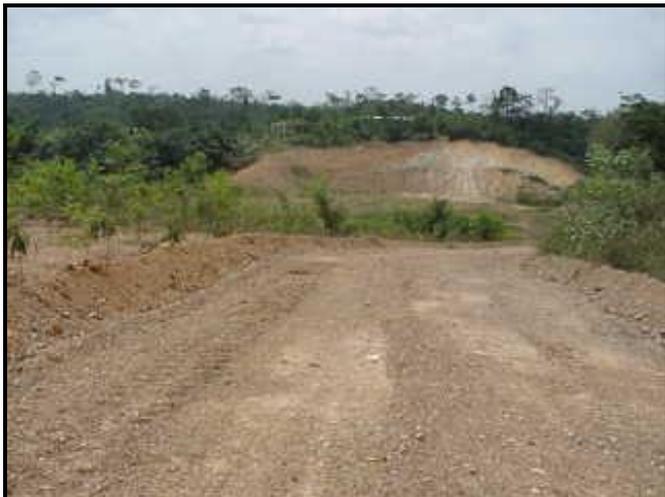
Photo 1.8

Extensive backfilling has been carried out with pit walls battered to gentle and stable slopes. Topsoil has been spread and vegetative cover put in place. Nitrogen fixing plant species have been introduced over a year ago and the growth performance is being monitored for improvement. Erosion control measures towards the northern slope have to be improved upon with reinforcement of undergrowth vegetation (Plate 2b).

All pit walls have been successfully battered and stable slope angles achieved. The land is gentle rolling and soil movement checked through consistent erosion control measures.

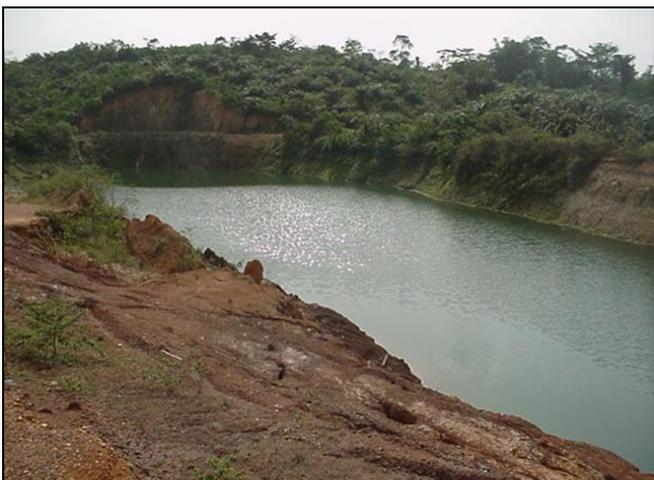
Photo 1.9

The walls of the pit are steep with an average slope of about 65° and are generally unstable. Weak zones and faults have developed in the east, west and north walls, with failures in the north and east walls. Erosion has caused gully developments in the slope faces. Manual remedial work would be undertaken to improve erosion and prevent any adverse instability problems.

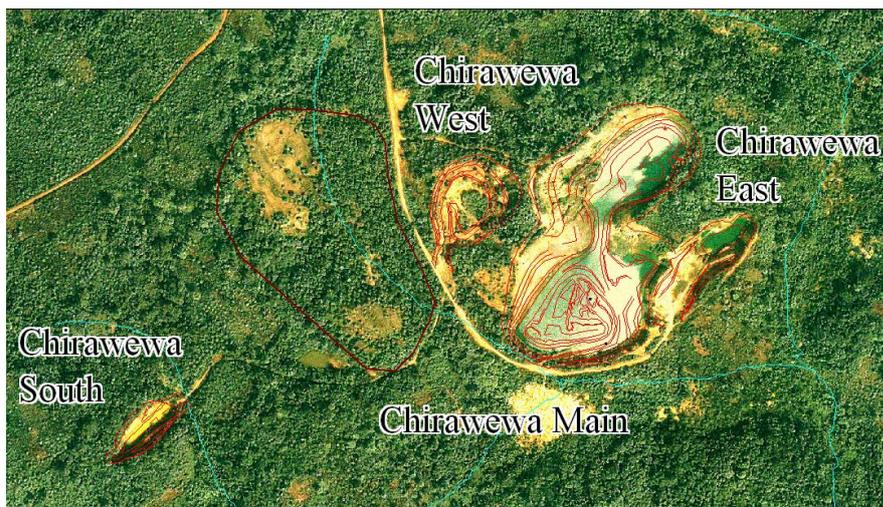
Photo 1.10

The circular wall of the pit has an average slope of 65°. There is only a bench of maximum height of about 25m and is in a stable condition. However, the illegal activity may create an unstable situation where they are working.

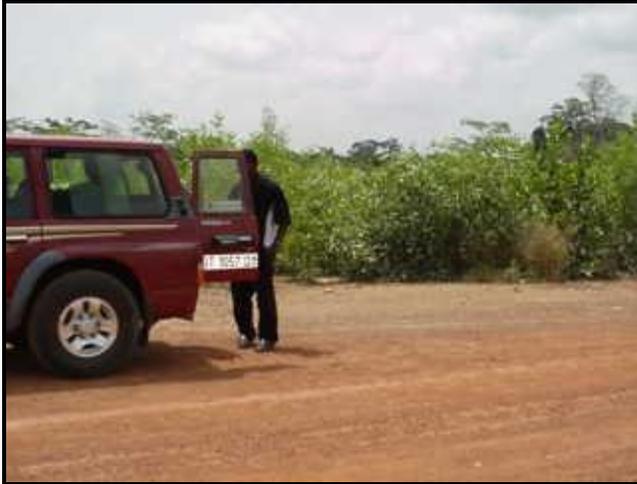
Photo 1.18

In backfilling North Esuajah pit, some of the material from this waste dump was recovered and used. The remaining heap of waste material was battered to obtain slope stability and topsoil spread on top for revegetation. Continuous erosion control activities have been designed to prevent soil damage and restore vegetation. Most of the species planted are nitrogen-fixing plants. To accelerate early vegetative undergrowth, both organic and inorganic fertilizers have been introduced. Deep ripping has reduced erosion considerably and there is a regular maintenance program in place to mitigate any negative topographic development (Plate 3b).

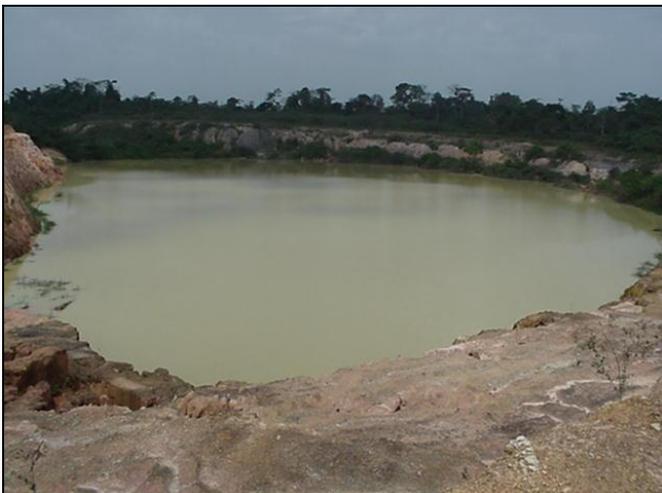
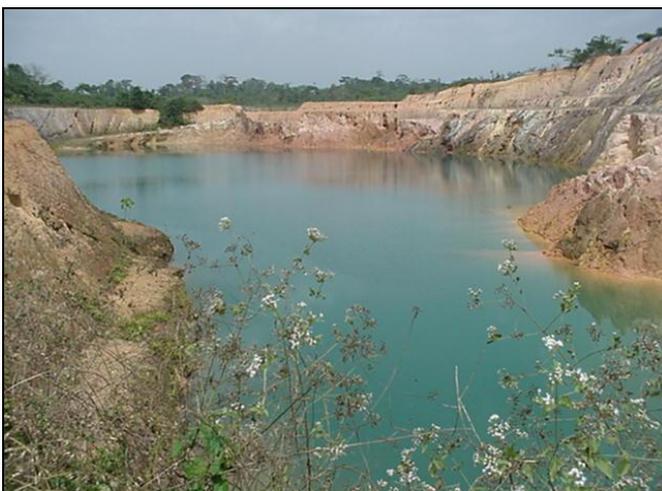
The walls of the pits are steep with an average slope of 65°. While the slopes of the north pit are fairly stable, the south pit walls have developed weak zones and minor slope failures. The effect of erosion is evidenced by the presence of gullies all over the slope faces. Manual remedial work would be undertaken to improve erosion and prevent any adverse instability problems.

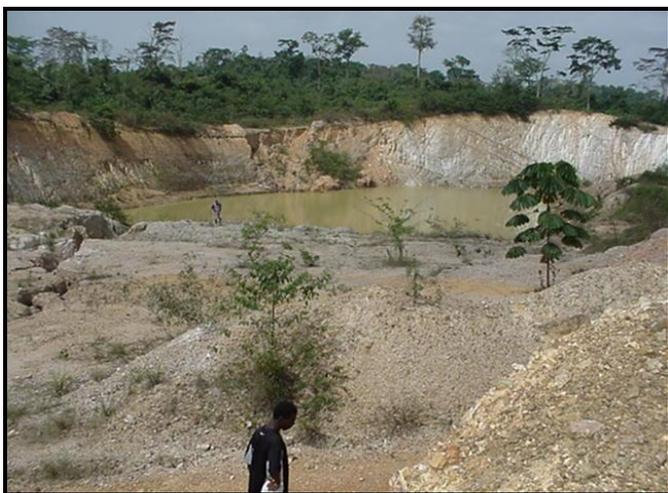
Photo 1.35

The pit is partially reclaimed by backfilling the southern end above daylight elevation, and the northern end filled with water to 10m deep leaving 30m of the wall above it. The area beyond the pit is covered with secondary forest and other vegetation (Plate10a). Illegal mining operation going on there is causing further land degradation in the area.

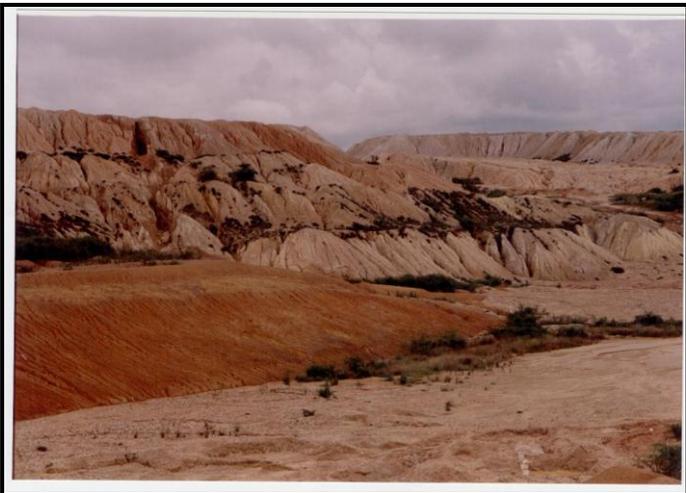
The 70° heap faces are generally unstable. Gully formation could undermine the berms provided and consequently accelerate slope failure. As part of the restoration, stability designs and works have tentatively been developed to address the negative impact.

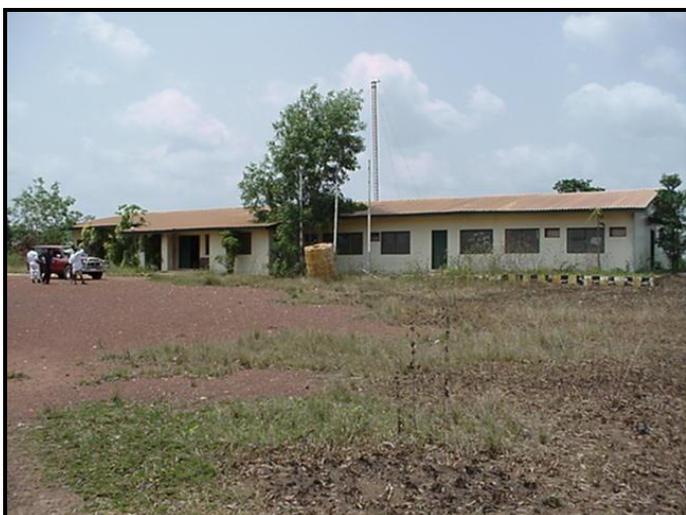
Photo 1.40

The facilities in this area are all in good structural conditions, but the inside of the clinic and the stores have been stripped of everything including the ceilings (Plate 15a).

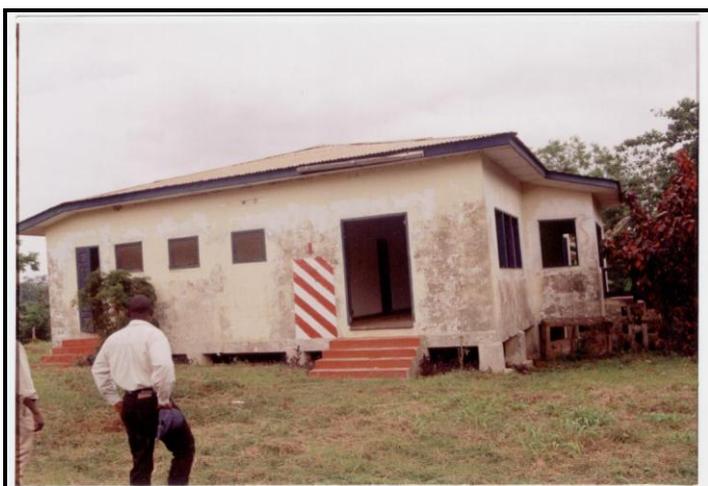
Photo 1.41

All the buildings are in good structural condition and can be used for any suitable activity (Plate 16a). However, most of the fittings and the utility facilities (louver blades and holders, plumbing accessories, electrical fittings, etc.) have either been destroyed or stolen.
