**APPENDIX 1.6**

**DESCRIPTION OF AGC FACILITIES**  
**AT TIME OF PROPOSED CLOSURE, 2004**

## 1.0 DESCRIPTION OF THE SITES<sup>1</sup>

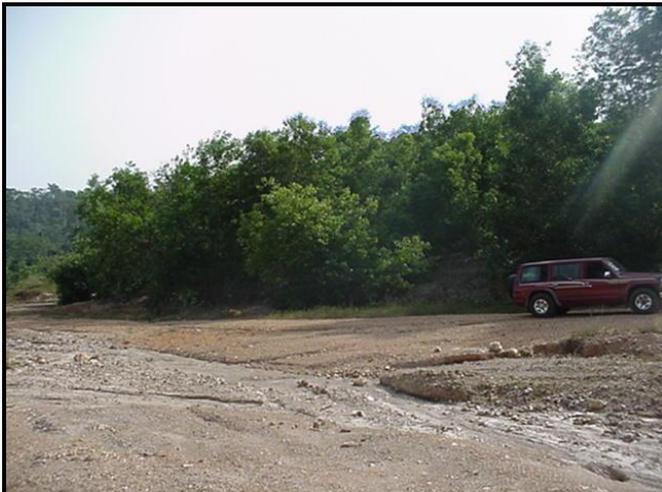
Photo 1.21

This waste dump is being turned into forestry with nitrogen fixing plants (Cassia species) having been planted already. Indigenous species will be introduced to attain the 40% plant population. . Meanwhile, the existing tree growth is being protected and enriched to improve the ecological restoration around the South Esuajah pit. The location of the dump makes it suitable for the creation of a forest belt to compliment the restoration work to be embarked on at the heap leach site.

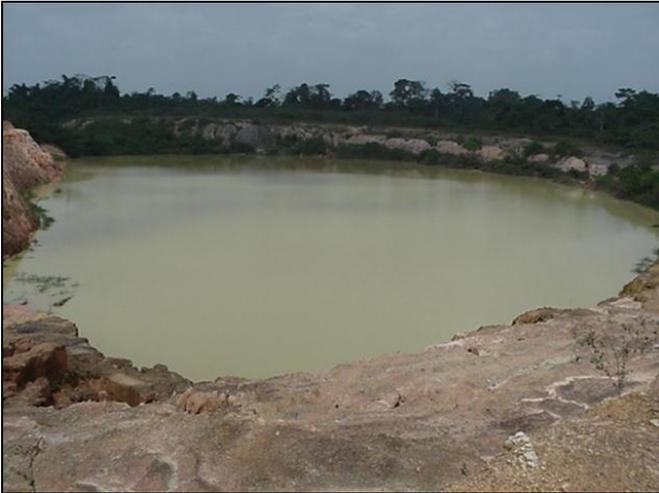
Photo 1.28 Fobinso North

The walls of the pits are steep with an average slope of 65°. While the slopes of the north pit are fairly stable, the south pit walls have developed weak zones and minor slope failures. The effect of erosion is evidenced by the presence of gullies all over the slope faces. Manual remedial work would be undertaken to improve erosion and prevent any adverse instability problems.

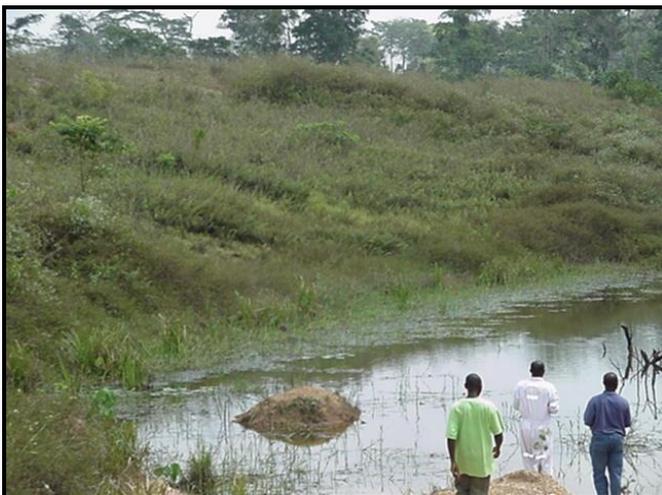
Photo 1.30 Fobinso North Dump Pond

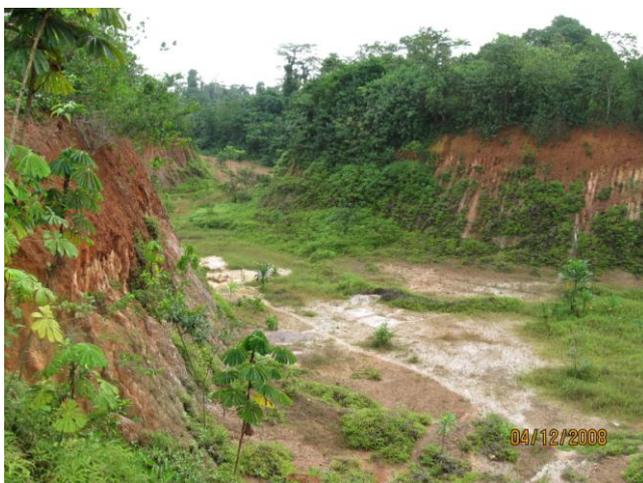
Photo 1.31 (CAGL 2008)

The walls of the pit are steep with an average slope of 65°. All the pit walls are in stable condition.
