APPENDIX 1.6

**DESCRIPTION OF AGC FACILITIES
AT TIME OF PROPOSED CLOSURE, 2004**

1.0 DESCRIPTION OF THE SITES¹

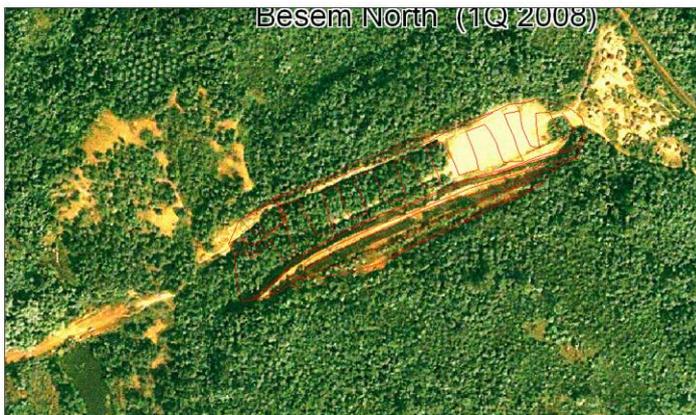
Photo 1.5

The pit has been reclaimed by backfilling above the daylight elevation, leaving 20m high pit walls to the east and the west flanks of 2 benches of 10m high. A portion of the reclaimed pit area has been turned into agro-forestry after the spread of topsoil and the provision of erosion control structures while the remaining land has been turned into a playing field (Plate 1a).

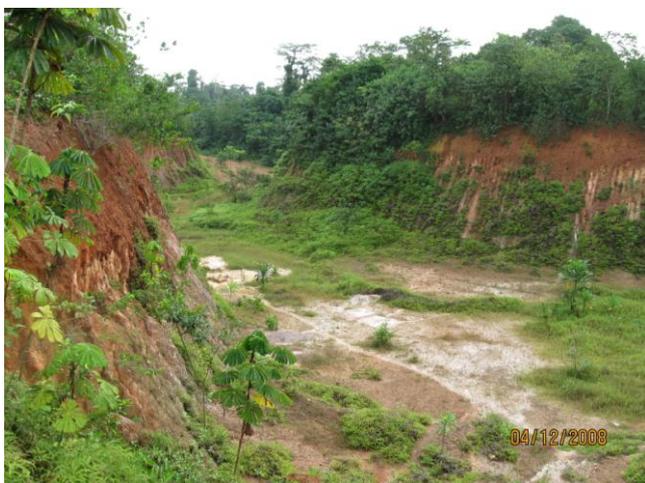
Photo 1.31 (CAGL 2008)

The walls of the pit are steep with an average slope of 65°. All the pit walls are in stable condition.

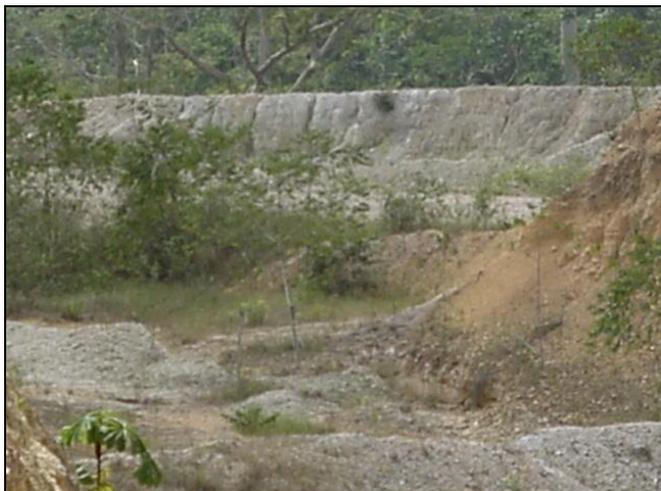
**Photo 1.36****Location**

Ntwintwina West Waste Dump was created some 50m southwest of the pit in a marshy valley. It is rectangular in shape, about 30m high with a perimeter of about 650m. Its total coverage area is about 2.85 hectares and contains about 460,000m³ waste materials.
